**Confidential Inspection Report**  
**123 Main St South**  
**Anytown , USA 99999**

**Prepared by: In Depth Home Inspection LLC**  
**5940 Smoketree Drive South East**  
**Salem, OR 97306**  
**503-991-7479 [Greg@InDepthHomeInspectionLLC.com](mailto:Greg@InDepthHomeInspectionLLC.com)**

**Report:** Sample 1 09

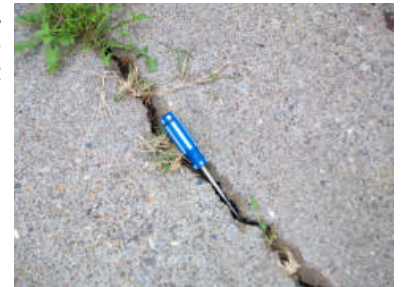
<i>Slab:</i>	p " "	Cracks noted - typical, Cracks noted - major. There are some major cracks on the outer most section of the patio.
--------------	-------	---

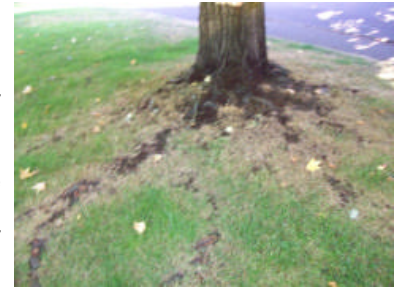
Big trees in the yard have significant root structure noted above grass. It can only be assumed that this exists under ground. The proximity to the driveway, walks and foundation is close. Therefore, buyer to observe for lifting, cracking of concrete and foundation in the future. Other landscaping okay.

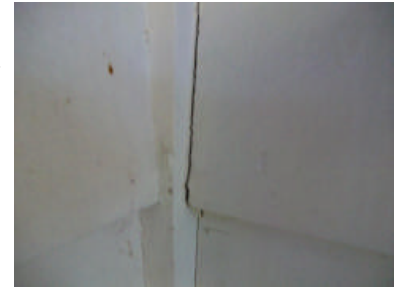
Walls are constructed with: Wood siding. Minor areas of caulking needed at the front corner near garage. Buyer to consider this as a yearly observation and typical maintenance.

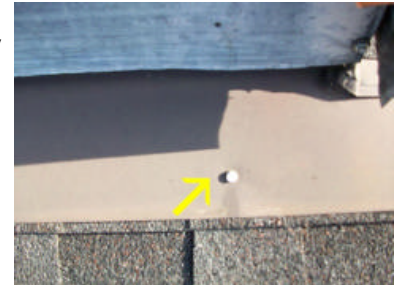
Caulking needed at flashing nails on roof. This is a yearly maintenance issue.

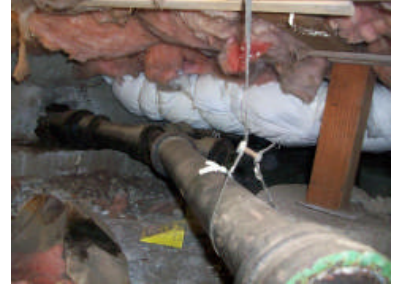
*Access:* Crawl space viewing is limited- solid ducting limited view to about 60% of crawl. The recent upgrade of HVAC system has solid ducting that will not flex for a body to slide under it. Therefore, I was not able to view all areas of the crawl. Access needs to be provided by digging out under pipes and ducts to allow a person to fully crawl the crawl space.

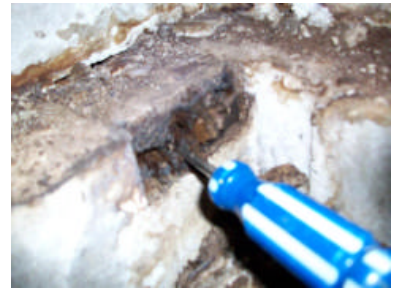
<i>Moisture:</i>	p .. ..	However, there are rotting block that are in the foundation footing. See pest report.
------------------	---------	---

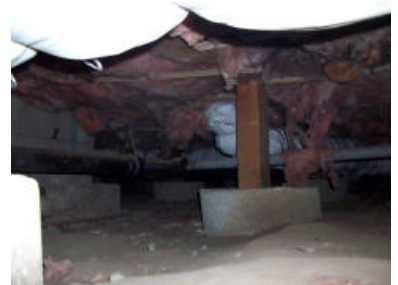
<i>In Unfinished Areas:</i>	.. .. p	There is only a vapor barrier in about 20% of the crawl.
-----------------------------	---------	--

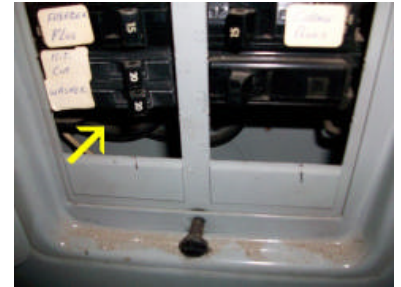
Circuit and wire sizing correct so far as visible, Grounding system is present, Knock-outs missing at panel. This is a significant hazard that allows direct access to the buss bars that are electrically charged. Install knock out covers.

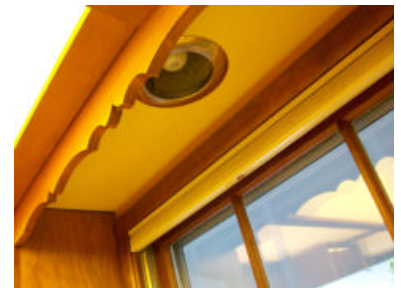
Okay. However, one light over the sink area does not turn on with the rest of the lights. It may be a burnt bulb. Consult the owner to issue with light.

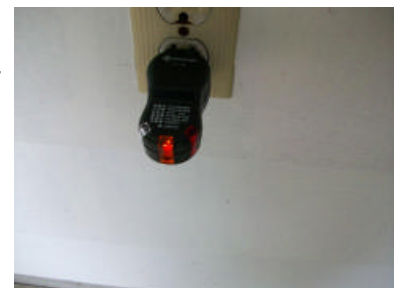
Two RV plugs noted on either side of the garage. Ground Fault Circuit Interrupter (GFCI) outlets are recommended for installation at exterior or basement locations. One outlet at patio is missing the ground.

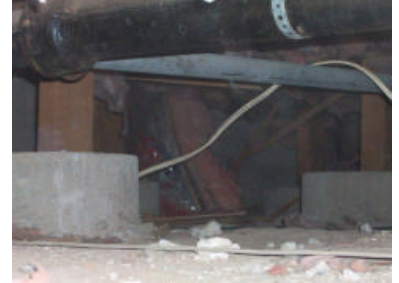
There is an electrical wire on the ground in the crawl. It needs to be supported properly under the house, not on the ground.

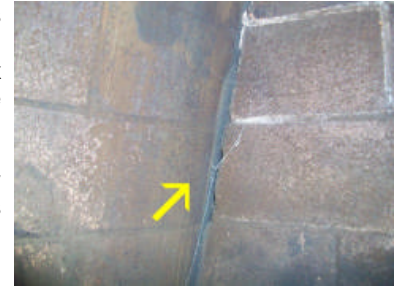
Masonry, Wood - The fireplace is designed to burn wood. Missing mortar, creating voids in the firebox walls, may present an unsafe condition during normal usage. Some replacement or repair is needed. Be sure to use refractory mortar in the firebox walls. There is a set of glass doors installed. Used correctly, these will help minimize heat loss when the fireplace is not in use. They also eliminate burning embers from flying into the room during a fire and reduce the volume of room air sucked up the chimney. The inspection is limited to the visible portions of the fireplace flue. Drop light, mirrors, and smoke testing are not a part of the inspection. Visibility in the flue is limited to as little as 20 percent. If further investigation is necessary, a qualified professional chimney sweep is recommended.

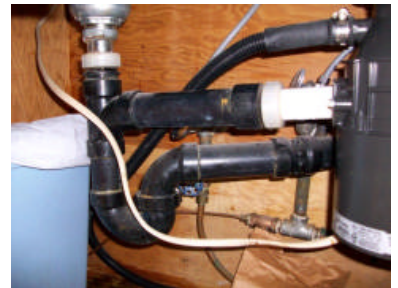
*Kitchen Sink:* .. p .. The drains are angled down toward the P trap, not toward the direction of the flow of the drain.

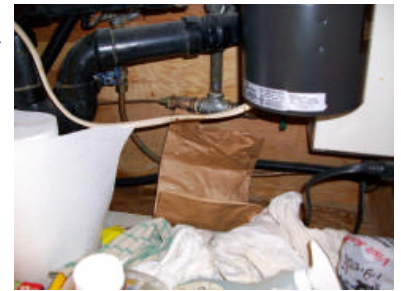
Protect wire under sink to the garbage disposal. Any wire under 7' must be protected inside a wall or conduit.

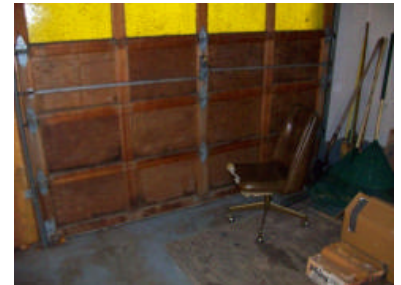
<i>Material - Condition:</i>	"	p	"	Adjustment or service needed on door closest to the kitchen. The door comes down to fast.
------------------------------	---	---	---	---

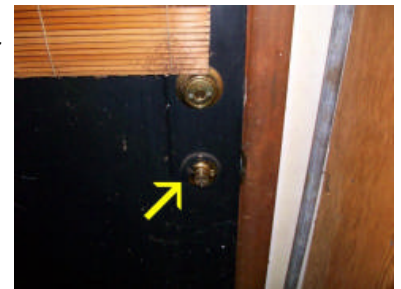
<i>Service Doors:</i>	"	"	p	Hardware operational, Door or its hardware needs repair or replacement. Needs door handle.
-----------------------	---	---	---	--

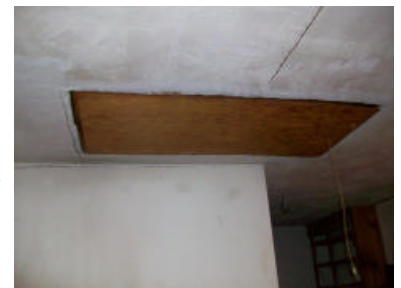
*Fire Wall*  
 The wall covering appears to meet the minimum fire separation standards. However, it is not possible to verify after the sheetrock is finished. The access to the attic requires 5/8" of sheet rock to provide fire protection. As it is now, the attic ladders plywood will burn through long before the sheet rock around it. Therefore the fire could burn in the attic possibly without being detected. The drywall helps keeps the fire in the garage until it can be extinguished.
