## **Confidential Inspection Report**

**123 Main St  
Salem, OR 97301**

**Prepared for: John Doe**

**Prepared by: In Depth Home Inspection LLC  
5940 Smoketree Drive South East  
Salem, OR 97306**

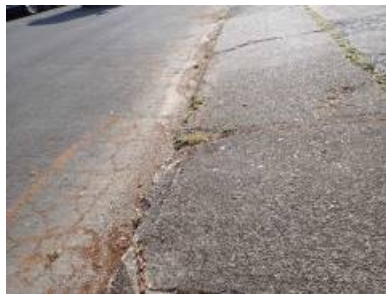
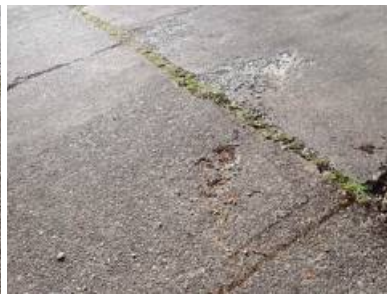
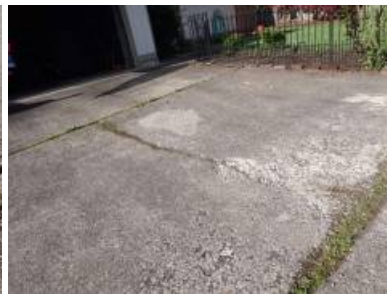
| | OK | MM | RR | |
|---|---|---|---|---|
| 2.1 Paving Conditions: | <input type="checkbox"/> | <input checked="" type="checkbox"/> | <input checked="" type="checkbox"/> | Concrete. Damage noted to approach, sidewalk and driveway. Erosion and deterioration of the concrete materials is present. Have a licensed contractor with experience in these conditions evaluate and repair or replace as necessary. |

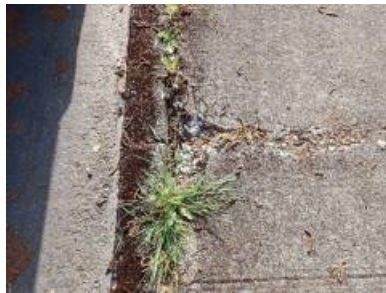
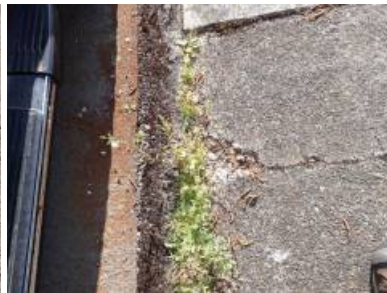
| | OK | MM | RR | |
|---|---|---|---|---|
| 2.2 Paving Conditions: | <input type="checkbox"/> | <input checked="" type="checkbox"/> | <input checked="" type="checkbox"/> | Concrete.. Damage noted to sidewalk similar to the driveway. Have a licensed contractor with experience in these conditions evaluate and repair or replace as necessary. |

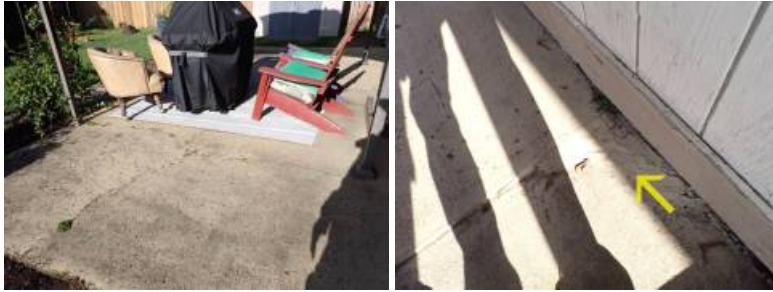
| | OK | MM | RR | |
|---|---|---|---|---|
| 2.4 Patio: | <input type="checkbox"/> | <input checked="" type="checkbox"/> | <input type="checkbox"/> | Patio type: Concrete. Carpet is covering the concrete surface preventing observation. Some settlement is noted. FYI. |

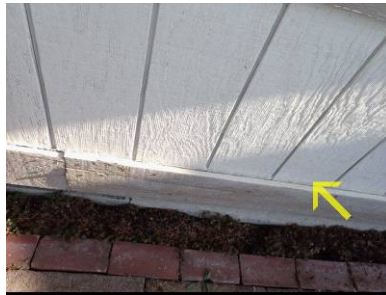
| 3.2 Exterior Walls - Siding/Cladding: | <input type="checkbox"/> | <input checked="" type="checkbox"/> | <input checked="" type="checkbox"/> | Exterior wall trim: Wood materials. Wood trim noted at the newer windows and other trim areas without visible flashing. Typically, flashing is installed over these areas to aid in draining any potential water that may get behind the siding. However, on this home the flashing is not installed at trim or windows. Additionally, window manufactures allow for the use of self healing tape around the window at the moisture barrier. Some do not require flashing. Due to the variety of the window types available from each manufacture, determining if these windows meet the requirement to not have flashing installed, is beyond the scope of the inspection. It is recommended that you contact the contractor, home owner or other party responsible for installation and have them provide you documentation that the windows or doors meet the installation method. If this is not a possibility, have a licensed contractor with experience in this area evaluate and repair as needed. Last, the trim at the bottom of the siding and some window trim, have warped, |

indicating a need for repair. Have a licensed contractor with experience in these conditions evaluate and repair or replace as necessary.

Flashing missing

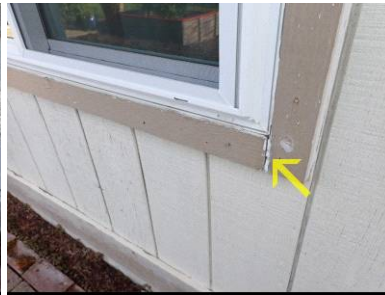
Twisting wood

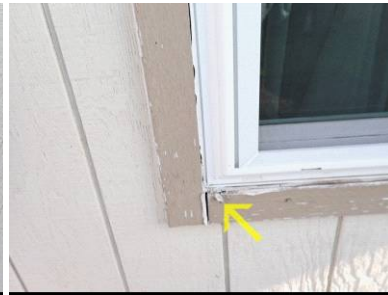
Cracking of trim

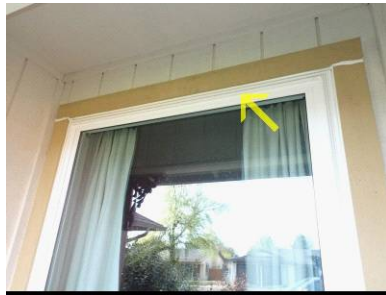
No flashing

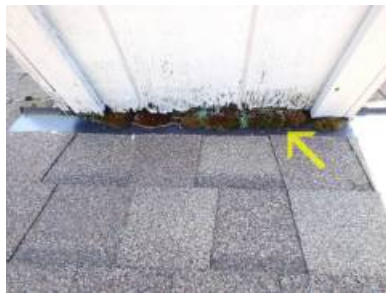
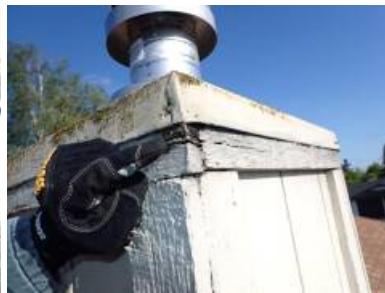
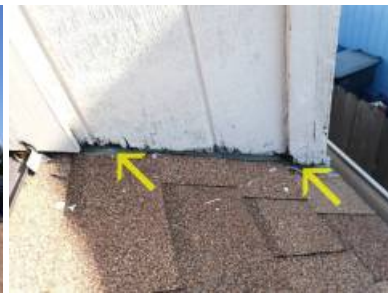
| 3.10 Chimney: | <input type="checkbox"/> | <input type="checkbox"/> | <input checked="" type="checkbox"/> | Siding is on the chase for the exterior of this fireplace flue. This is allowable. The interior of the chase is not visible. While this is typical construction style, it does restrict viewing of conditions possibly present. On the exterior of the chimney, there is visible rot at some areas of siding and trim. These will need repair. All siding should be cut back 2 inches from the roofing materials. Have a licensed contractor with experience in these conditions evaluate and repair or replace as necessary. |

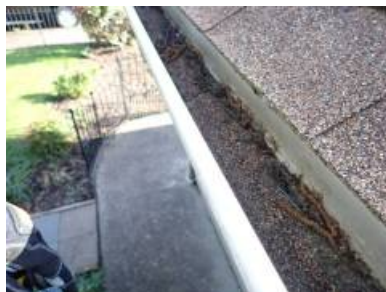
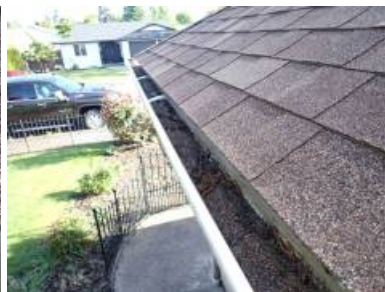
| 4.2 Gutters: | <input type="checkbox"/> | <input checked="" type="checkbox"/> | <input type="checkbox"/> | Minor debris in gutter and/or downspouts. Not keeping these clear can cause issues with roof sheeting, soffits, fascia and drainage issues inside downspouts and underground drainage. Gutters, down spouts and drain lines need to be cleaned to prevent damage to the structure. This is periodic maintenance. Have a licensed contractor with experience in these conditions evaluate and repair or replace as necessary. |

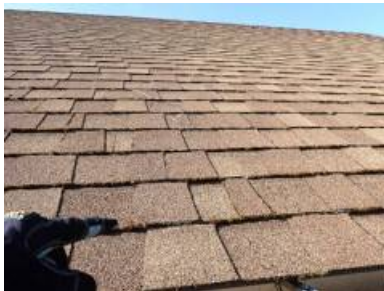
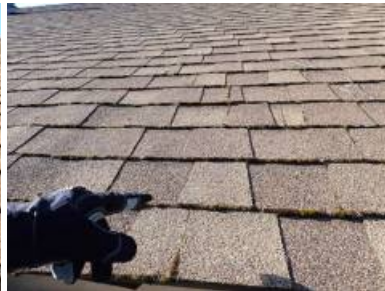
4.9 Roof: ☐ ☒ ☐ Minor to moderate moss treatment needed on the roof. This is typical maintenance. Have a licensed contractor with experience in these conditions evaluate and repair or replace as necessary.

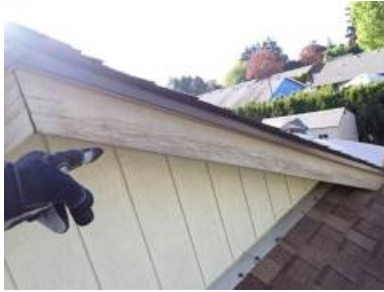
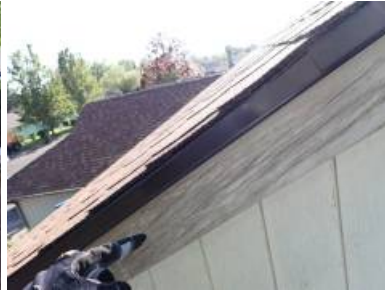
| 4.19 Roof: | <input type="checkbox"/> | <input checked="" type="checkbox"/> | <input checked="" type="checkbox"/> | Paint needed on eaves, soffit and/or fascia boards to protect from further damage. Have a licensed contractor with experience in these conditions evaluate and repair or replace as necessary. |

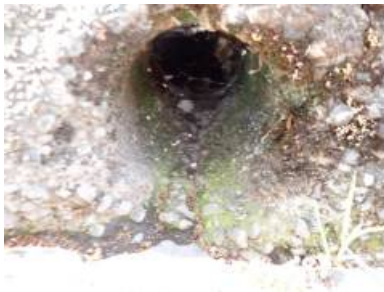
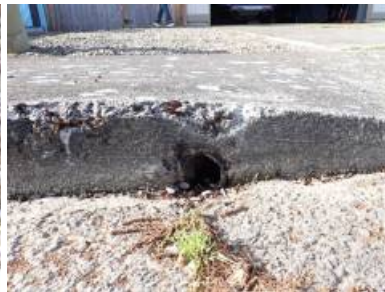
| 4.21 Gutters: | <input type="checkbox"/> | <input type="checkbox"/> | <input type="checkbox"/> | Underground drainage noted to the street. The drains are not able to be observed as they are buried. It is always recommended that these ground drains are scoped to determine the condition of the buried drain. This can be completed by the same contractor, when you have a sewer scope completed. Scoping this drainage, is beyond the scope of the Oregon Home Inspection. |

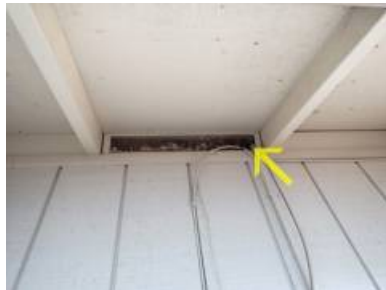
| 4.28 Attic & Insulation: | <input type="checkbox"/> <input checked="" type="checkbox"/> <input type="checkbox"/> | Soffit venting in place. Gap in soffit vent screen near AC unit. This can allow birds and small animals into the attic. Seal the hole. Have a licensed contractor with experience in these conditions evaluate and repair or replace as necessary. |

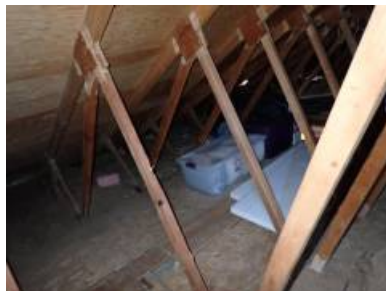
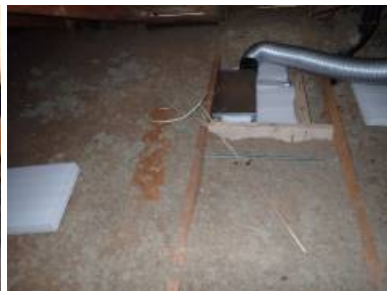
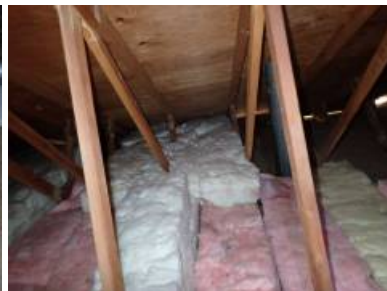
| 4.29 Attic & Insulation: | <input type="checkbox"/> <input checked="" type="checkbox"/> <input type="checkbox"/> | Cellulose- Blown. Fiberglass batts. Some insulation is installed unevenly. Recommend additional insulation in the attic area to help with energy efficiency. It is recommended that you achieve an R value of R-38. But you should consider adding enough for and R-49 value as that is much more superior. Have a licensed contractor with experience in these conditions evaluate and repair or replace as necessary. |

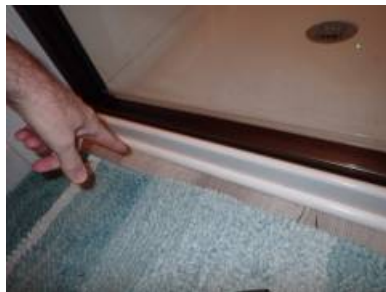
| 6.27 Primary Bathroom: | <input type="checkbox"/> | <input type="checkbox"/> | <input checked="" type="checkbox"/> | The caulking in the water contact areas appears to need attention. Damage may result if not corrected. Need caulking at the floor near the shower/tub. Have a licensed contractor with experience in these conditions evaluate and repair or replace as necessary. |

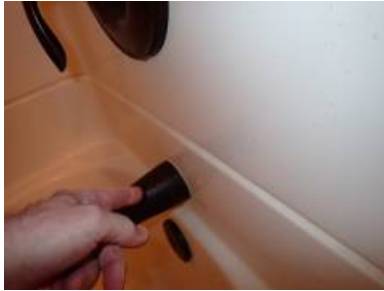
| | OK | MM | RR | |
|---|---|---|---|---|
| 6.32 Bathroom #2: | <input type="checkbox"/> | <input type="checkbox"/> | <input checked="" type="checkbox"/> | The point where the faucet meets the wall of the tub/shower, needs caulking to prevent water from entering the wall area. Have a licensed contractor with experience in these conditions evaluate and repair as necessary. |

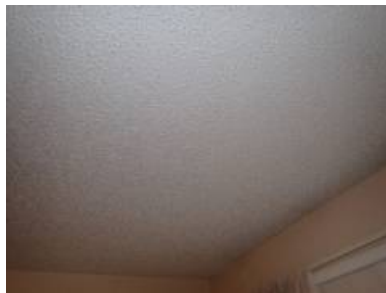
| 7.32 General Type & Condition: | <input checked="" type="checkbox"/> <input checked="" type="checkbox"/> <input type="checkbox"/> | General condition appears serviceable, Typical cracks noted. The insides of the wall cavities were not observed. We are limited to visual signs on the outer wall surfaces to determine conditions present and cannot see through the walls to detect concealed damage, organic growth, wood destroying insect damage, wood destroying organism activity, insulation, or any other concealed conditions inside the walls. The evaluation inside of the walls is not possible without the use of destructive discovery. Cracks, patches and other disfigurement is typical with older construction and camouflage conditions beyond the surface area. Destructive discovery is against the Oregon Standards of Practice for Home Inspectors. Popcorn ceiling noted. This matter has been known to have asbestos materials. The only way to determine if there is asbestos in the material is to have it tested. This should be completed by a licensed contractor certified to do such testing. |

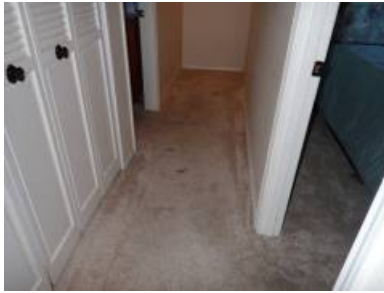
| | OK | MM | RR | |
|---|---|---|---|---|
| 7.40 General: | <input checked="" type="checkbox"/> | <input checked="" type="checkbox"/> | <input type="checkbox"/> | General condition indicate the floor coverings are serviceable. Cosmetic conditions are not part of the inspection. Heavy wear noted in various locations. Replacement needed in the near future. At the very least, clean the carpets and be prepared to replace them. Have a licensed contractor with experience in these conditions evaluate and repair or replace as necessary. |

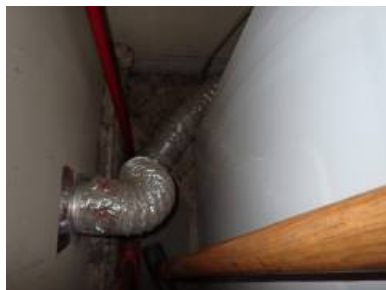
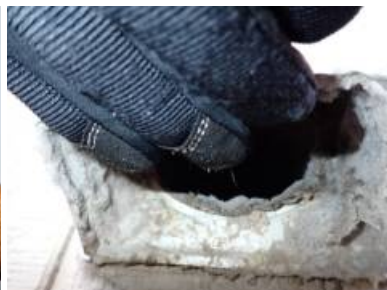
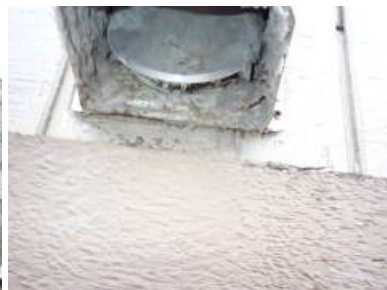
8.9 Laundry: ☐ ☒ ☐ Foil and/or vinyl ducting present at dryer to permanent ducting. This is not preferred as it is more susceptible to catching lint and then possibly becoming a fire hazard. Either smooth wall or semi ridged metal ducting should be used. Assure duct is clean prior to use. Have a licensed contractor with experience in these conditions evaluate and repair or replace as necessary.

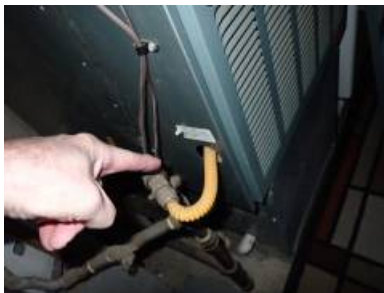
| 9.14 Heating Equipment: | <input type="checkbox"/> <input type="checkbox"/> <input checked="" type="checkbox"/> | Natural Gas. Shut off present. Gas flex line installed into the furnace. The area of the cabinet penetration for the gas line, has the potential to cut the appliance flex gas line. A sleeve over the gas line is needed or hard gas line to the exterior of the furnace is needed and the flex line still needs to be present but on the exterior of the furnace. Due to the conditions observed, have a licensed HVAC technician evaluate and repair as needed. |

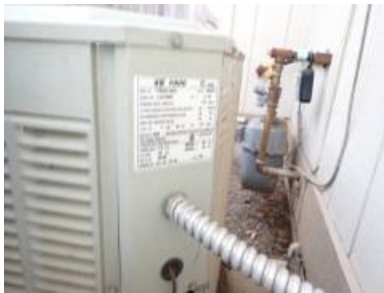
| | OK | MM | RR | |
|---|---|---|---|---|
| 9.17 Air Conditioning: | <input checked="" type="checkbox"/> | <input checked="" type="checkbox"/> | <input type="checkbox"/> | 1996. Although unit may be functional, plan for replacement in near future. |

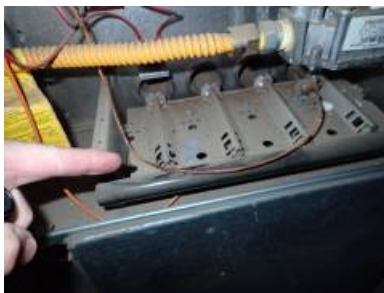
| 9.18 Heating Equipment: | <input type="checkbox"/> | <input checked="" type="checkbox"/> | <input type="checkbox"/> | Operational. Suggest cleaning/servicing blower motor, burners, evaporative coils, condenser, heat coils, and cabinet. Not all of these items are installed on every furnace or heat pump. Have what is installed, serviced. Total unit needs cleaning. Have an HVAC tech service unit and determine if repairs are needed. Also, consider having a service contract put on unit to assure safety and quality operation year after year. Doing so will help prevent unwanted breakdowns at the most inconvenient time. |

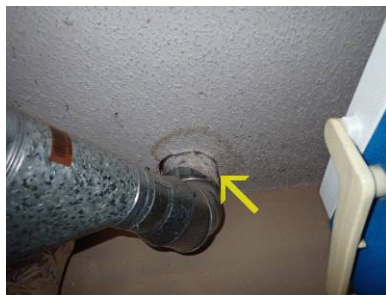
| 9.22 Heating Equipment: | <input type="checkbox"/> | <input type="checkbox"/> | <input checked="" type="checkbox"/> | The flue pipe is metal. B-vent noted in appropriate areas. You need to maintain a clearance of 1" around all "B-Vent" venting. This is at the ceiling. The roof termination has corrosion and needs repair. Flashing is lifting at roof area. This could allow for a leak to occur. Due to the conditions observed, have a licensed HVAC technician evaluate and repair as needed. |

Need 1" clearance

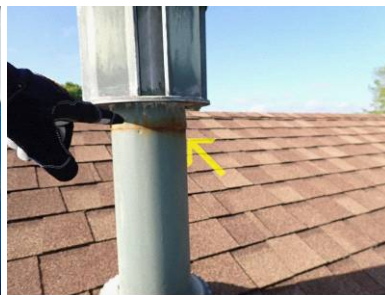
Corrosion

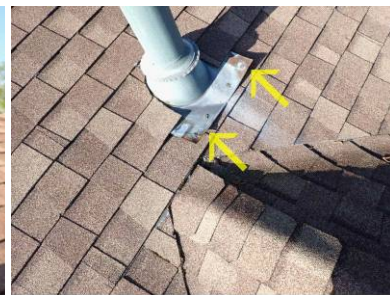
Flashing lifting

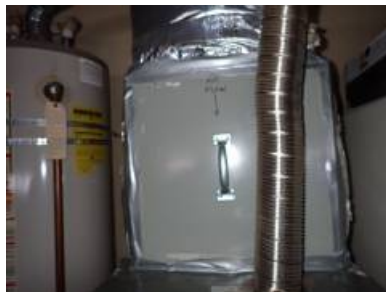
| 9.23 Heating Equipment: | <input type="checkbox"/> | <input checked="" type="checkbox"/> | <input type="checkbox"/> | Unable to access the filter due to the installation of duct tape at the access door. Assure filter is changed regularly. |

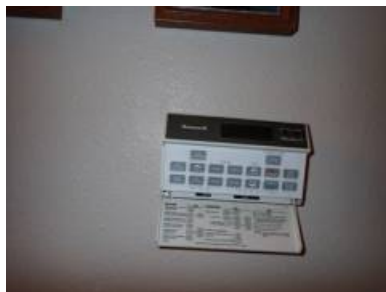
| 9.24 Heating Equipment: | <input checked="" type="checkbox"/> | <input checked="" type="checkbox"/> | <input type="checkbox"/> | Thermostat is located in the Hall. Electronic thermostat controls for central HVAC system. Secure thermostat to the wall. Have a licensed contractor with experience in these conditions evaluate and repair or replace as necessary. |

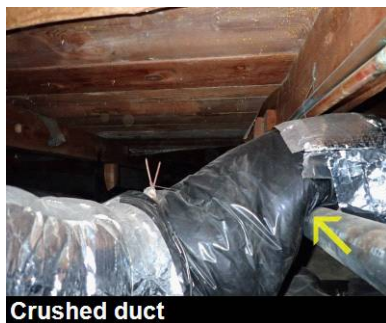
| 9.29 Heating Equipment: | <input type="checkbox"/> | <input type="checkbox"/> | <input checked="" type="checkbox"/> | Insulated sheet metal. Many ducts in the crawlspace are laying on the floor. They should be supported at least 3 inches off the crawl floor. Also, one small section of flex duct is crushed. Due to the conditions observed, have a licensed HVAC technician evaluate and repair as needed. |

Crushed duct

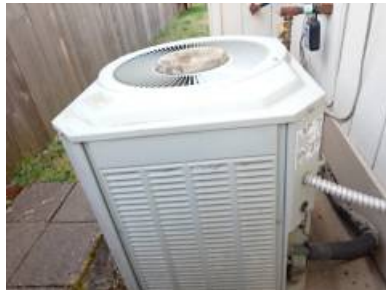
| | OK | MM | RR | |
|---|---|---|---|---|
| 9.30 Air Conditioning: | <input type="checkbox"/> | <input checked="" type="checkbox"/> | <input type="checkbox"/> | Outside air temperature was below 65 degrees. I am unable to test system at this time due to the accepted standards of practice for home inspectors as testing this equipment under 65 degrees may damage the unit. It is best to have the AC system evaluated by a licensed HVAC technician at this time to determine if there are any issues present. This is a limitation to the inspection. Unit needs to be balanced on slab as it is out of level and can cause issues with the condensing unit. Due to the conditions observed, have a licensed HVAC technician evaluate and repair as needed. |

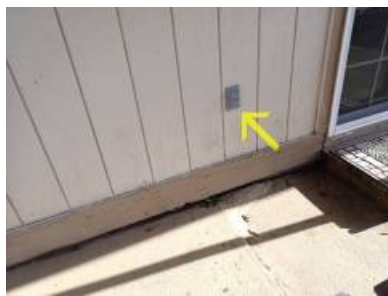
| | OK | MM | RR | |
|---|---|---|---|---|
| 10.1 Exterior Walls - Siding/Cladding: | <input type="checkbox"/> | <input type="checkbox"/> | <input type="checkbox"/> | GFCI portion of the outlets not tested as these could be connected to the garage outlets that may not be accessible currently. See garage outlet section. |

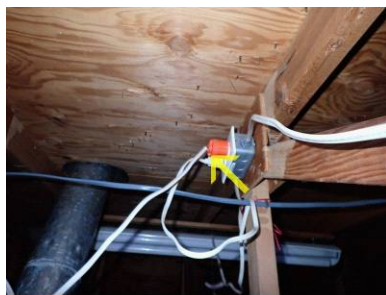
| 10.13 Attic & Insulation: | <input type="checkbox"/> <input type="checkbox"/> <input checked="" type="checkbox"/> | Secure cabling. All wiring needs to be secured every 4.5'. Secure cabling near junction boxes within 12" of fixture or junction box. One junction box needs to be secured in middle of attic. Open splice noted at attic fan. Wiring being used in a substandard manner with a plug into an outlet. Secure cabling near junction boxes within 12" of fixture or junction box. Due to the condition/conditions observed, recommend that a licensed electrical contractor with experience in this/these condition(s) evaluate and repair as necessary. |

Substandard installation

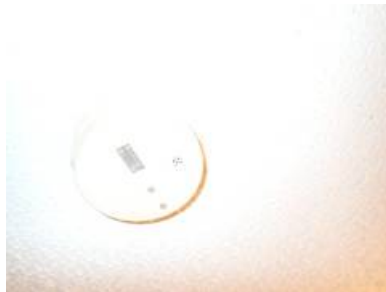
| 10.27 Hall: | <input type="checkbox"/> | <input type="checkbox"/> | <input checked="" type="checkbox"/> | There is a nonworking and/or out dated smoke alarm in this room. For safety considerations, it needs to be repaired or replaced immediately. The current standard is a smoke alarm must be less than 10 years old. This home was built without a hardwired alarm to this room, therefore the alarm is allowed to be a battery only unit. This is the current requirement from the Oregon State Fire Marshall and the AHJ (Authority Having Jurisdiction) is to have a detector that is no older than 10 years old. Have a licensed contractor with experience in these conditions evaluate and repair as necessary. |

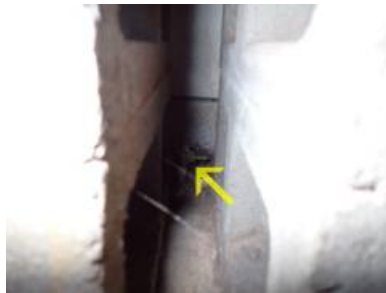
| 10.44 Structures Service: | <input type="checkbox"/> | <input checked="" type="checkbox"/> | <input type="checkbox"/> | Currently, there is only one ground rod. The new standard is to have two ground rods. Consider upgrading to meet this new requirement. Due to the condition/conditions observed, recommend that a licensed electrical contractor with experience in this/these condition(s) evaluate and repair as necessary. |

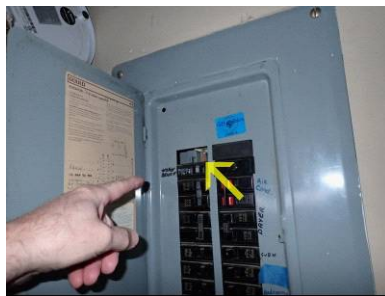
| | OK | MM | RR | |
|---|---|---|---|---|
| 10.48 Structures Main Electrical Service Panel(s): | <input type="checkbox"/> | <input type="checkbox"/> | <input checked="" type="checkbox"/> | Split buss panel found. Six or fewer breakers in one location do not usually require a main breaker. While this panel is no longer used, it is still allowed. Consider upgrading to current standards panel. Energized identification needed on white energized lines into breakers to identify that they are charged instead of a neutral line. Knock-out(s) missing inside the panel. These should be plugged. Missing wire protection at panel where wire penetrates the metal box. Each wire should be attached to the box by a clamp or bushing to prevent damage to the wire. Unused openings in the panel are missing covers. These should be plugged to prevent shock and fire hazard. Due to the condition/conditions observed, recommend that a licensed electrical contractor with experience in this/these condition(s) evaluate and repair as necessary. |

Opening in front cover

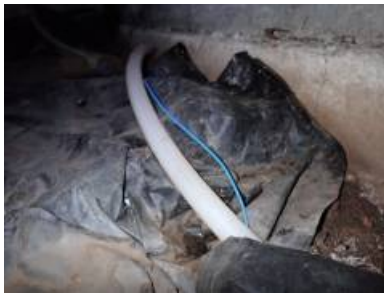
| Supply Line Insulation: | | | | | |
|---|---|---|---|---|---|
| | 11.9 Structures Main Line: | <input type="checkbox"/> | <input type="checkbox"/> | <input checked="" type="checkbox"/> | There is no insulation on the pipe supplying water to the home. Insulation should be installed to protect pipes from freezing. Have a licensed contractor with experience in these conditions evaluate and repair or replace as necessary. |

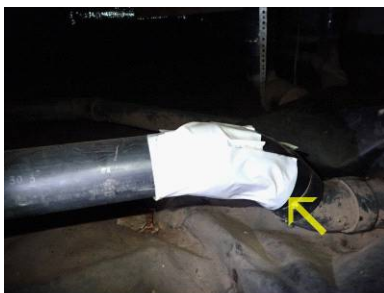
| Condition: | | | | |
|---|---|---|---|---|
| 11.12 Waste Lines (drain, Waste, Vent Pipes): | <input type="checkbox"/> | <input type="checkbox"/> | <input checked="" type="checkbox"/> | Lines not fully visible due to construction style. This is typical for the era in which the home was constructed. Observe the attic (if present) and the crawlspace as well as any unfinished areas, for changes in the condition of the plumbing, whether it be the supply or the drainage (DWV) piping. Plumbing vents appear serviceable. There is a leak in the crawlspace under the primary bathroom sink drain. Water on pipe and on vapor barrier indicates there is a leak. Also, there is a substandard repair to a waste pipe between both bathrooms, in the crawlspace. Due to the condition/conditions observed, recommend that a licensed plumber with experience in this/these condition(s) evaluate and repair as necessary. |

Substandard repair

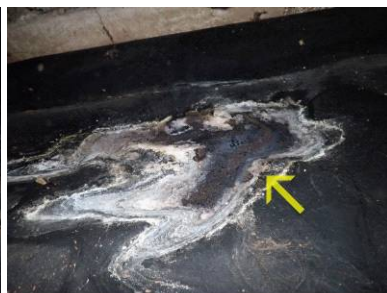
Puddle

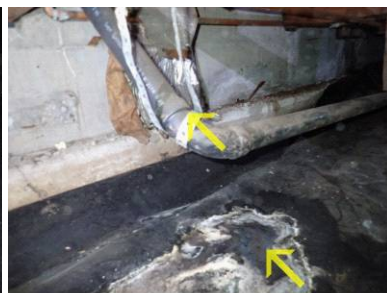
Leak and puddle

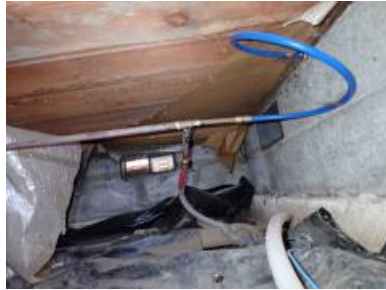
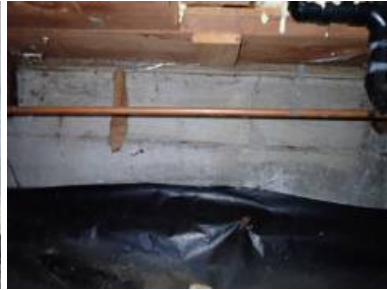
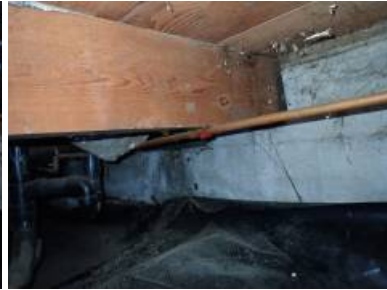
| | OK | MM | RR | |
|---|---|---|---|---|
| 11.13 Supply Lines: | <input type="checkbox"/> | <input type="checkbox"/> | <input checked="" type="checkbox"/> | There is no insulation or missing insulation, on the pipes supplying water to the home. Insulation should be installed to protect pipes from freezing. Have a licensed contractor with experience in these conditions evaluate and repair or replace as necessary. |

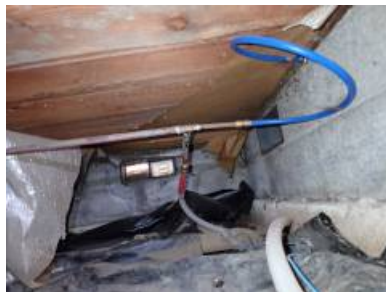
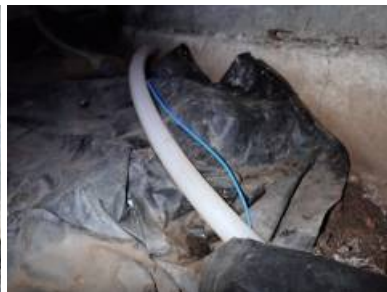
| 11.14 Supply Lines: | <input type="checkbox"/> | <input checked="" type="checkbox"/> | <input type="checkbox"/> | Proper support needed at NW corner of crawl where the new fresh water lines are installed. Have a licensed contractor with experience in these conditions evaluate and repair or replace as necessary. |

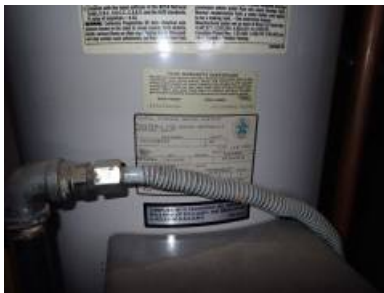
| 11.23 Water Heater: | <input type="checkbox"/> | <input checked="" type="checkbox"/> | <input type="checkbox"/> | Possibly 1994. The unit is old. Water heaters typical life span is 8 to 12 years per the industry standard. This unit is either within that life span or older. I have seen water heater last much longer than this time span with proper maintenance. Be aware that the unit could need replacement at any time. Use until it goes out then contact a licensed plumber with experience in this/these condition(s) evaluate and repair as necessary. |

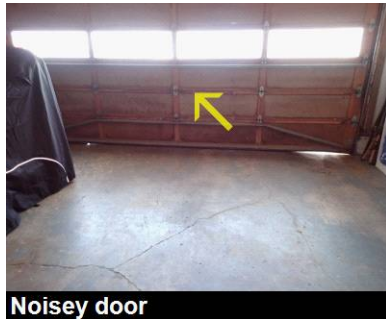
| | OK | MM | RR | |
|---|---|---|---|---|
| 12.1 Garage Door(s): | <input checked="" type="checkbox"/> | <input checked="" type="checkbox"/> | <input type="checkbox"/> | Operational. Door has some sag noted. This will only continue and eventually will need repair or replacement. This is also leaving gaps at the bottom of the door that could allow vermin into the garage. In garage door only: Unable to determine if glass is tempered in the garage door. Tempered glass should be installed in a movable door. This door may predate the requirement but the glass still should be upgraded. Operational. However, the door(s) make(s) excessive noise during use. Servicing the door(s) and opener(s) is needed. Have a licensed contractor with experience in these conditions evaluate and repair or replace as necessary. |

Noisey door

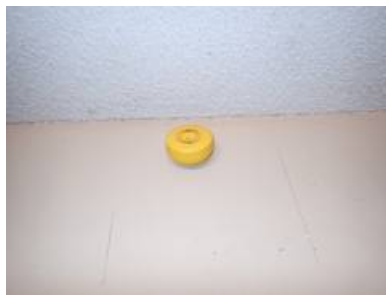
| 12.3 Garage: | <input checked="" type="checkbox"/> | <input checked="" type="checkbox"/> | <input type="checkbox"/> | Indications are this area is serviceable. Indications are this area is serviceable. Smoke alarms are not recommended in this area. This unit is greater than 10 years only anyway. FYI. |

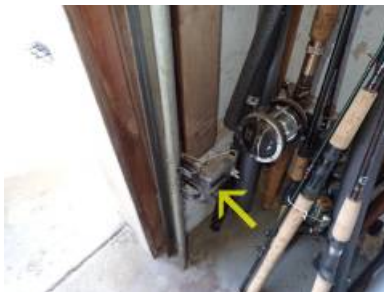
Eyes are operational. They reverse the door when the beam is interrupted. Photo eyes are installed too high off the garage floor. The auto reverse eyes should be mounted 4-6" off the finished floor surface. Have a licensed contractor with experience in these conditions evaluate and repair or replace as necessary.

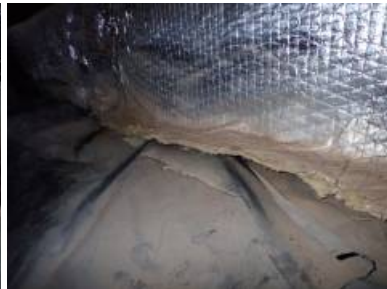
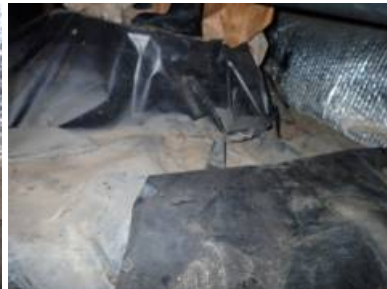
| | OK | MM | RR | |
|---|---|---|---|---|
| 13.5 Crawlspace: | <input checked="" type="checkbox"/> | <input checked="" type="checkbox"/> | <input type="checkbox"/> | There are historic stains noted on footings/piers and/or vapor barrier that indicate a significant amount of water was in the crawlspace at one time. I am not able to determine the cause or if it is a past or current issue. Observe for changes. Currently the crawlspace is dry. |

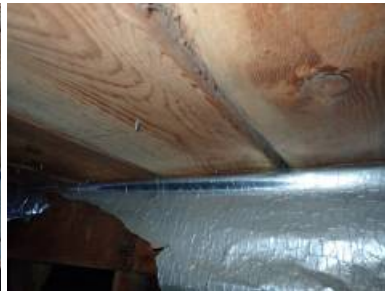
| 13.9 Crawlspace: | <input type="checkbox"/> | <input checked="" type="checkbox"/> | <input type="checkbox"/> | No insulation installed under the floor. You may want to add insulation for energy savings and comfort. Foil in place between the beams. Restricts underside of the floor viewing for potential wood destroying insects or rot damage. It is beyond the scope of the home inspection to remove and re-install the foil to evaluate the sub floor material. Foil under the floor between the joists. It can hide conditions that which would normally be visible if it were not in place. Every attempt was made to examine sample areas and areas that have reason for concern. However, the inspection is a limited visual inspection. Therefore, there are no guarantees. |

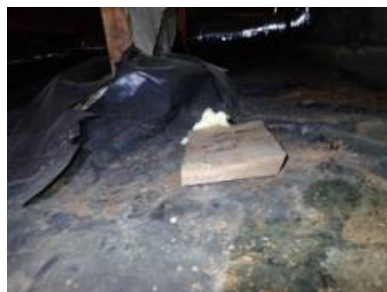
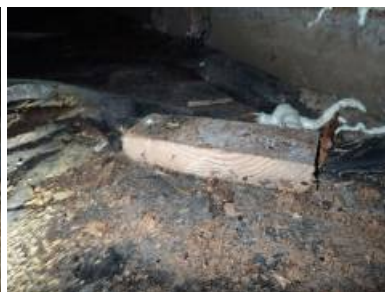
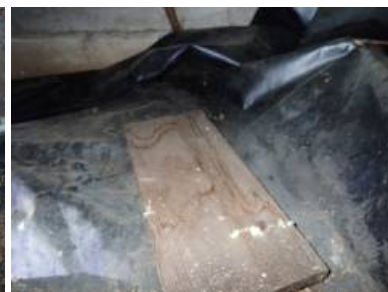
| 13.13 Crawlspace: | <input type="checkbox"/> | <input checked="" type="checkbox"/> | <input type="checkbox"/> | There is cellulose debris in the crawl space. All cellulose debris should be removed to detour the infestation of WDOs in the crawl space. The entire crawl should be free of cellulose debris. The under-floor grade should be cleaned of all vegetation and organic material. Have a licensed contractor with experience in these conditions evaluate and repair or replace as necessary. |

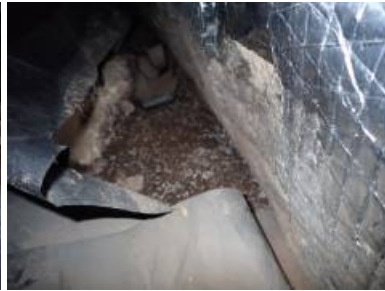
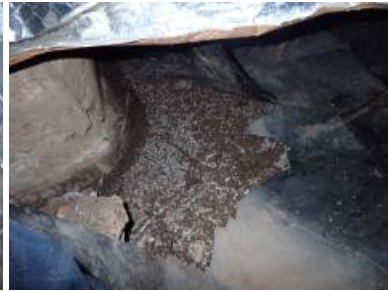
| 13.17 Vapor Barriers In Crawlspace: | <input checked="" type="checkbox"/> | <input checked="" type="checkbox"/> | <input type="checkbox"/> | There is a vapor barrier installed. There is a vapor barrier installed at the floor area of the crawlspace. The floor is covered with an approved vapor/moisture retardant material. There are small section(s) of ground that are exposed. The entire crawlspace should be covered with at least a 6 mil black vinyl covering. Any seams should overlap 12" and the vapor barrier should go up the foundation wall 12". Have a licensed contractor with experience in these conditions evaluate and repair or replace as necessary. |
