## **Confidential Inspection Report**

**123 Main St  
Salem, OR 97301**

**Prepared for: John Doe**

**Prepared by: In Depth Home Inspection LLC  
5940 Smoketree Drive South East  
Salem, OR 97306**

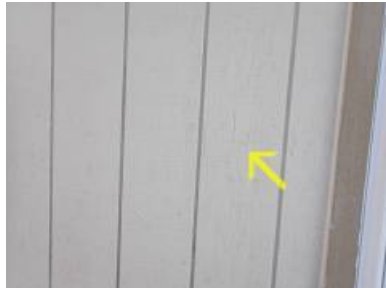
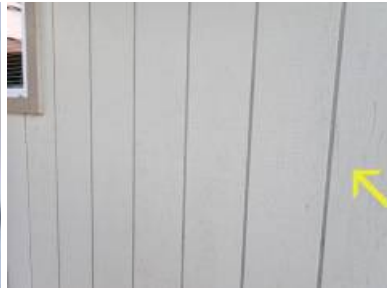
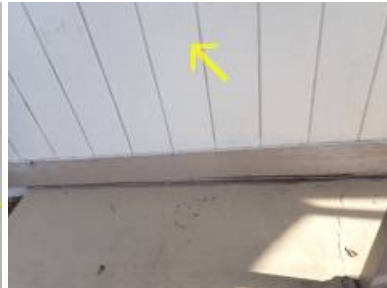
| | OK | MM | RR | |
|---|---|---|---|---|
| 3.1 Exterior Walls - Siding/Cladding: | <input type="checkbox"/> | <input checked="" type="checkbox"/> | <input checked="" type="checkbox"/> | Exterior walls are constructed with: T-111 Plywood. Indications are most of the siding is serviceable. The south and some of the west siding has cracking or what is called checking. The surface wood is splitting. While you can buy some time with painting the surface regularly, the areas with cracks will eventually need replacement. Areas of caulk and paint are needed currently. Have a licensed contractor with experience in these conditions evaluate and repair or replace as necessary. |

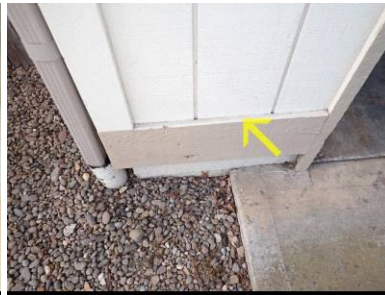
No flashing

| 3.2 Exterior Walls - Siding/Cladding: | <input type="checkbox"/> | <input checked="" type="checkbox"/> | <input checked="" type="checkbox"/> | Exterior wall trim: Wood materials. Wood trim noted at the newer windows and other trim areas without visible flashing. Typically, flashing is installed over these areas to aid in draining any potential water that may get behind the siding. However, on this home the flashing is not installed at trim or windows. Additionally, window manufactures allow for the use of self healing tape around the window at the moisture barrier. Some do not require flashing. Due to the variety of the window types available from each manufacture, determining if these windows meet the requirement to not have flashing installed, is beyond the scope of the inspection. It is recommended that you contact the contractor, home owner or other party responsible for installation and have them provide you documentation that the windows or doors meet the installation method. If this is not a possibility, have a licensed contractor with experience in this area evaluate and repair as needed. Last, the trim at the bottom of the siding and some window trim, have warped, |

indicating a need for repair. Have a licensed contractor with experience in these conditions evaluate and repair or replace as necessary.

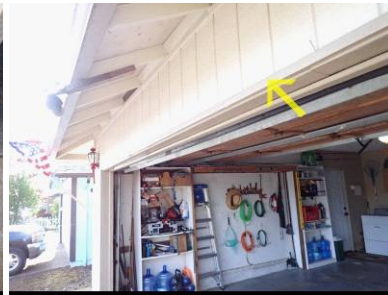
No flashing

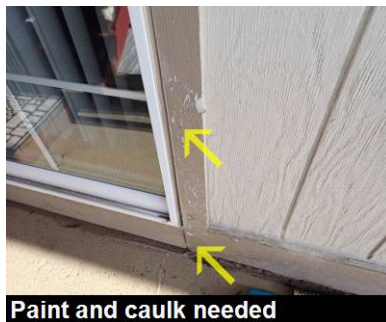
No flashing

Paint and caulk needed

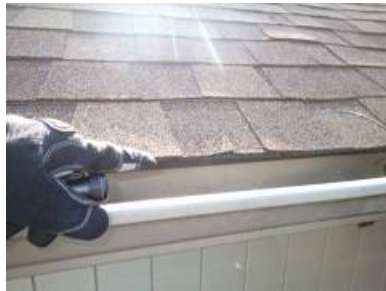
| 4.14 Roof: | <input type="checkbox"/> | <input type="checkbox"/> | <input checked="" type="checkbox"/> | Drip edge metal installed incorrectly at the eave (gutter). While the drip edge metal may or may not be required by the manufacture, when the roof was installed, it should be under the underlayment, not over the underlayment at the gutters edge (eave). This should direct water into the gutter in the event that water or condensation gets behind the shingles. The current installation can influence water towards the sheeting of the roof decking at the gutter edge. Therefore, the flashing at the gutters (eaves), should be installed under the underlayment to direct any potential water into the gutters. All the manufactures instructions I have read instruct for this to be installed this way. Thus repair is recommended. Be advised that some roofing contractors have other perspectives on this issue that may not be in line with the manufactures recommendations and current building standards. Have a licensed roofing contractor with experience in these conditions evaluate and repair as necessary. |

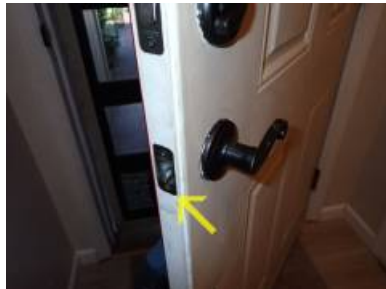
| | OK | MM | RR | |
|---|---|---|---|---|
| 7.5 Hall: | <input type="checkbox"/> | <input type="checkbox"/> | <input checked="" type="checkbox"/> | The latch does not operate as intended. Have a licensed contractor with experience in these conditions evaluate and repair or replace as necessary. |

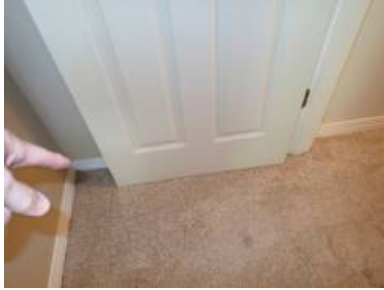
| 7.9 Bedroom #2: | <input checked="" type="checkbox"/> | <input checked="" type="checkbox"/> | <input type="checkbox"/> | Hardware operational. Flooring to door. Over time opening the door will damage the flooring. Shortening or adjustment of the door is needed. Have a licensed contractor with experience in these conditions evaluate and repair or replace as necessary. |

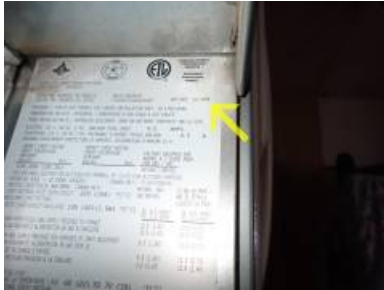
| 9.16 Heating Equipment: | <input type="checkbox"/> <input checked="" type="checkbox"/> <input type="checkbox"/> | 2004. Although operational at the time of the inspection, the age and/or condition of this unit is such that you may need to replace it in the near future. |

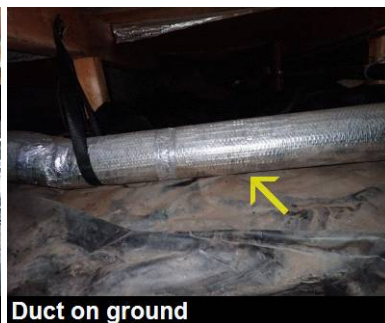
Duct on ground

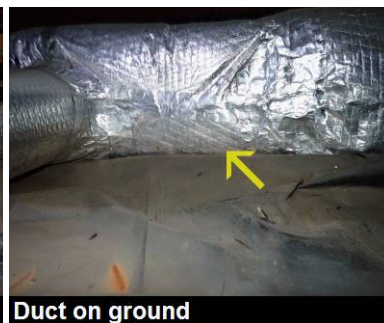
Duct on ground

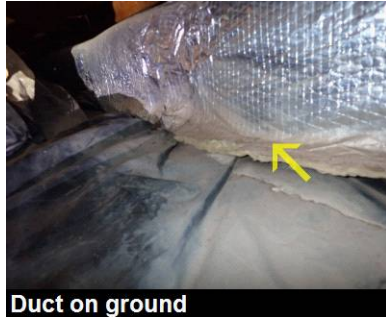
Duct on ground

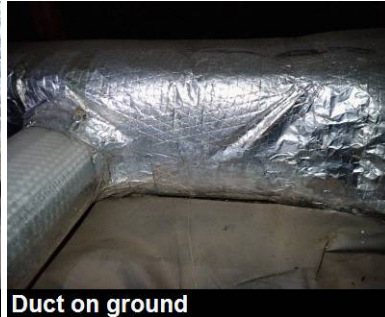
Duct on ground

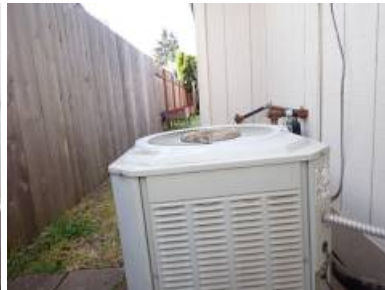
| | OK | MM | RR | |
|---|---|---|---|---|
| 9.30 Air Conditioning: | <input type="checkbox"/> | <input checked="" type="checkbox"/> | <input type="checkbox"/> | Outside air temperature was below 65 degrees. I am unable to test system at this time due to the accepted standards of practice for home inspectors as testing this equipment under 65 degrees may damage the unit. It is best to have the AC system evaluated by a licensed HVAC technician at this time to determine if there are any issues present. This is a limitation to the inspection. Unit needs to be balanced on slab as it is out of level and can cause issues with the condensing unit. Due to the conditions observed, have a licensed HVAC technician evaluate and repair as needed. |

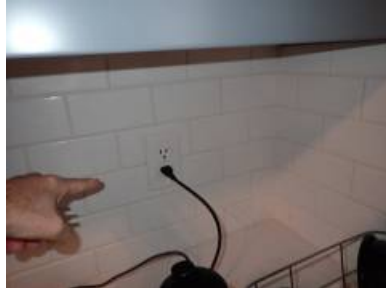
| | OK | MM | RR | |
|---|---|---|---|---|
| 10.2 Kitchen Interior: | <input type="checkbox"/> | <input type="checkbox"/> | <input checked="" type="checkbox"/> | This area does not have a Ground Fault Circuit Interrupt outlet installed. The age of the structure may predate the required installation. However, for safety considerations, it is strongly recommended that one be installed at any location within 6 feet of a water source or area susceptible to possible moisture. Ground Fault Circuit Interrupter (GFCI) outlets are recommended for installation at exterior, garage, bath rooms, |

| | | kitchens, unfinished basements, utility rooms with outlets other than the washer/dryer/ironing board outlets. This should be considered a Buyers Safety Upgrade. Due to the condition/conditions observed, recommend that a licensed electrician with experience in this/these condition(s) evaluate and repair as necessary. |

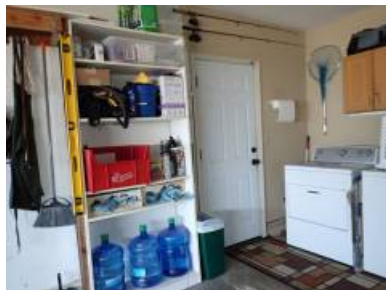
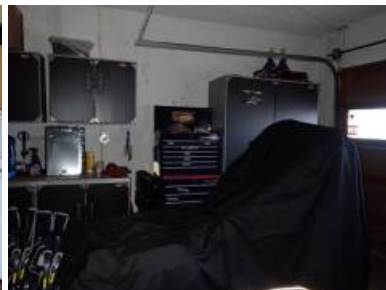
| | OK | MM | RR | |
|---|---|---|---|---|
| 10.9 Garage: | <input type="checkbox"/> | <input checked="" type="checkbox"/> | <input type="checkbox"/> | Unable to access all outlets to determine if there are GFCI outlets due to stored items. Assure that all outlets in garage are GFCI protected unless they are a single receptacle on a designated circuit for a single appliance such as a freezer (or other single appliance) only. The garage GFCI likely operates the exterior outlets as well. Assure the exterior outlet have GFCI protection. |

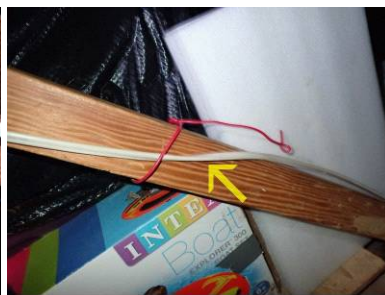
Properly secure wire

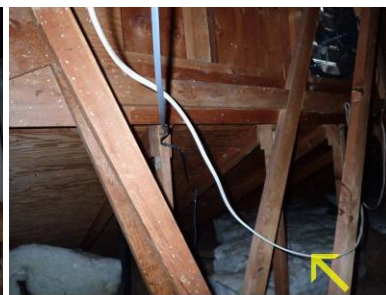
Properly secure wire

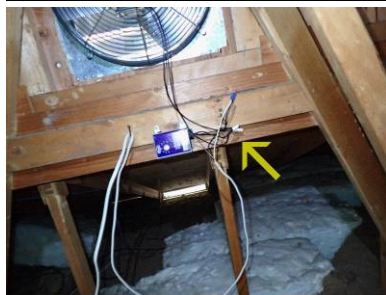
Open splice

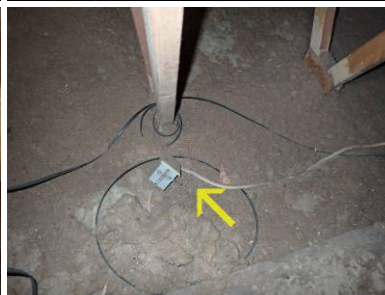
Secure wire and junction box

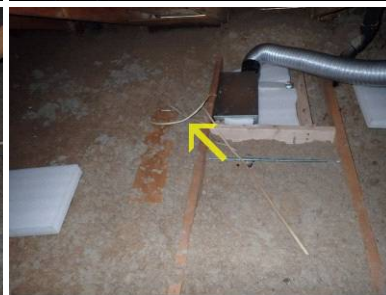
Secure wire

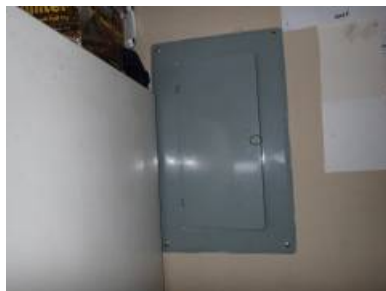
| 10.47 Structures Main Electrical Service Panel(s): | <input type="checkbox"/> | <input checked="" type="checkbox"/> | <input type="checkbox"/> | Garage. Clearance to access the panel should be at least 36" in front and at least 30" on both sides. Cabinets or other stored items diminish this clearance and accessibility. This area should be kept clear at all times. |

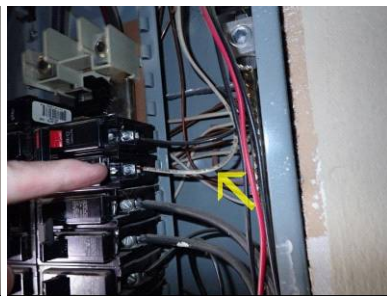
Reidentify as energized

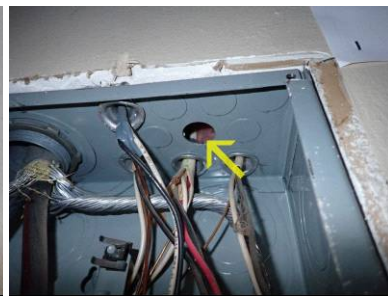
Cap opening

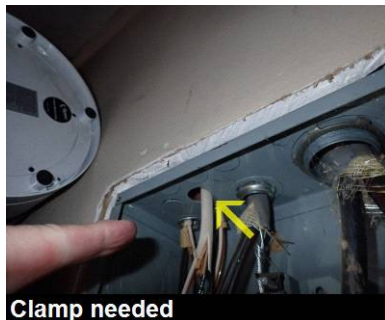
Clamp needed

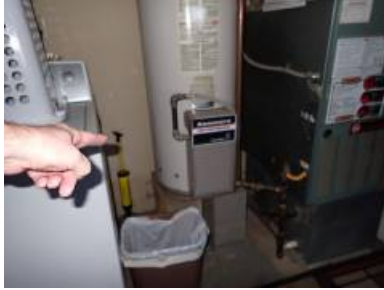
| 11.27 Water Heater: | <input type="checkbox"/> | <input type="checkbox"/> | <input checked="" type="checkbox"/> | Water heater is not correctly or inadequately secured and needs to be strapped in accordance with local standards. Locally, the water heater is strapped down with a strap on the top 1/3 and one at the bottom 1/3 of the water heater. This is to prevent the water heater from tipping over in a natural disaster such as an earth quake. There is either no strap or only one strap installed. Proper strapping is needed. Also, this water tank can be used as a fresh water supply for drinking water in the event there is a natural disaster and you have shut the inlet valve to prevent water loss and contamination. Also if water heater is strapped away from the wall, blocking will need to be added to prevent movement. Have a licensed contractor with experience in these conditions evaluate and repair or replace as necessary. |

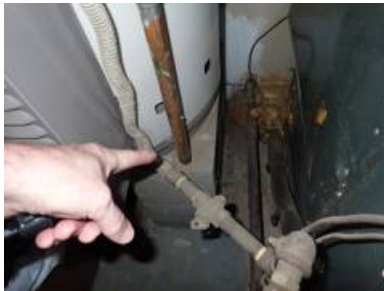
| | OK | MM | RR | |
|---|---|---|---|---|
| 11.28 Water Heater: | <input type="checkbox"/> | <input type="checkbox"/> | <input checked="" type="checkbox"/> | Temp pressure relief valve or safety relief valve, noted but not tested. Typically, the valve will leak when opened for the first time after years of use, if it is not checked regularly by current occupant. Therefore, home inspectors do not operate this valve. After purchase, I suggests you open the valve monthly to check its ability to open and function. If it will not seal, the valve needs to be replaced. The purpose of the valve is to release pressure from the hot water tank if the heating element/burner, malfunctions (prevents the tank from exploding). Pressure relief valve drain line is missing or ends prematurely. This drain line should be extended to a safe location and terminate within 2' of the walking surface at the water heater but greater than 6" off the ground surface. Have a licensed contractor with experience in these conditions evaluate and repair or replace as necessary. |

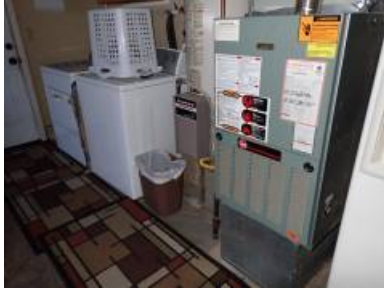
| 11.32 Water Heater: | <input type="checkbox"/> | <input type="checkbox"/> | <input checked="" type="checkbox"/> | Impact bollard needed to prevent damage to appliance in the event an auto gets too close. Have a licensed contractor with experience in these conditions evaluate and repair or replace as necessary. |

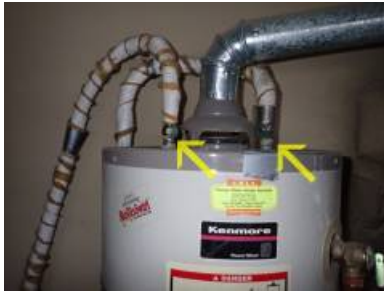
| | OK | MM | RR | |
|---|---|---|---|---|
| 11.33 Water Heater: | <input type="checkbox"/> | <input checked="" type="checkbox"/> | <input type="checkbox"/> | There is corrosion noted near or at one or more of the nipples, the TPR, and/or associated plumbing valve used to connect into the water tank or associated plumbing. Repair is needed to prevent leaks from occurring. Due to the condition/conditions observed, recommend that a licensed plumber with experience in this/these condition(s) evaluate and repair as necessary. |

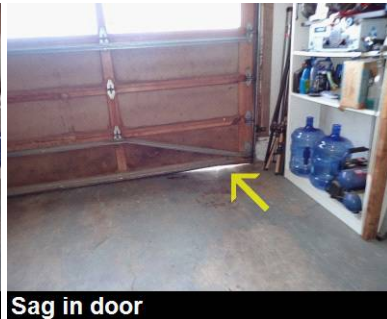
Sag in door

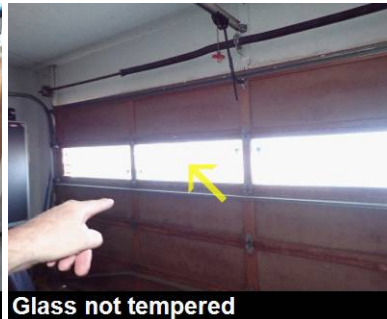
Glass not tempered

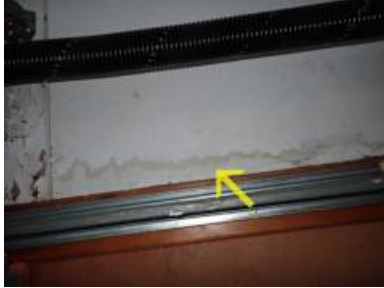
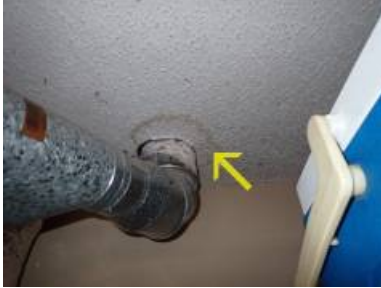
| | OK | MM | RR | |
|---|---|---|---|---|
| 12.5 Garage: | <input type="checkbox"/> | <input checked="" type="checkbox"/> | <input type="checkbox"/> | General condition appears serviceable. However, there is staining over the garage door and at the furnace flue, indicating water intrusion. The areas are dry currently. Further evaluation is recommended. Have a licensed contractor with experience in these conditions evaluate and repair or replace as necessary. |

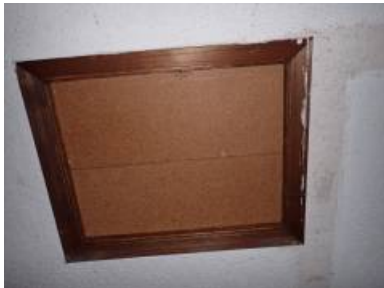
| 12.6 Garage: | <input type="checkbox"/> | <input type="checkbox"/> | <input checked="" type="checkbox"/> | Although it is not possible to determine if the sheet rock is fire resistive with out destructive discovery (due to the Oregon Standards of Practice for Home Inspectors) the current surface of the wall (and/or ceiling) structure has indications that it is a sheet rock/drywall surface. The only way to tell if it is actually fire rated it to cause damage. I am not allowed to do any damage to the home. The AHJ (Authority Having Jurisdiction) approves a fire wall of 1/2" drywall for single stories and 5/8" for living spaces above the garage. The access to the attic is not fire separation rated. The door should seal and have at least 1/2" (when installed on single level home and 5/8" when there is a living space above this area) drywall installed that is fire separation rated, to stop the spread of fire into the attic space. Have a licensed contractor with experience in these conditions evaluate and repair as necessary. |

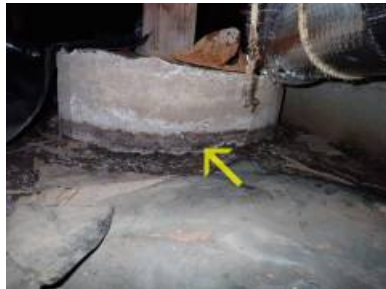
| | OK | MM | RR | |
|---|---|---|---|---|
| 13.5 Crawlspace: | <input checked="" type="checkbox"/> | <input checked="" type="checkbox"/> | <input type="checkbox"/> | There are historic stains noted on footings/piers and/or vapor barrier that indicate a significant amount of water was in the crawlspace at one time. I am not able to determine the cause or if it is a past or current issue. Observe for changes. Currently the crawlspace is dry. |

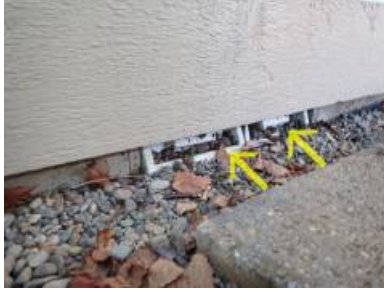
| | OK | MM | RR | |
|---|---|---|---|---|
| 13.7 Crawlspace: | <input type="checkbox"/> | <input checked="" type="checkbox"/> | <input type="checkbox"/> | The cross-ventilation openings in the crawlspace appears to be adequate. Vents to the crawlspace are sealed. This prevents the normal air movement needed. Open the vents to allow normal function. Vent wells should be installed at exterior vents to the crawl where grade is just below or over the vent opening. This prevents water and debris from being introduced into the crawl from this opening. Have a licensed contractor with experience in these conditions evaluate and repair or replace as necessary. |

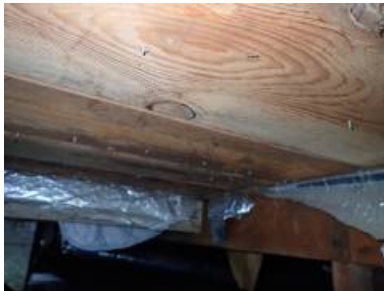
| 13.9 Crawlspace: | <input type="checkbox"/> | <input checked="" type="checkbox"/> | <input type="checkbox"/> | No insulation installed under the floor. You may want to add insulation for energy savings and comfort. Foil in place between the beams. Restricts underside of the floor viewing for potential wood destroying insects or rot damage. It is beyond the scope of the home inspection to remove and re-install the foil to evaluate the sub floor material. Foil under the floor between the joists. It can hide conditions that which would normally be visible if it were not in place. Every attempt was made to examine sample areas and areas that have reason for concern. However, the inspection is a limited visual inspection. Therefore, there are no guarantees. |

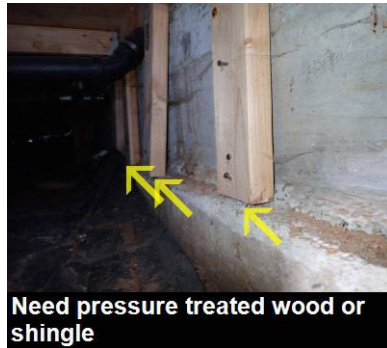
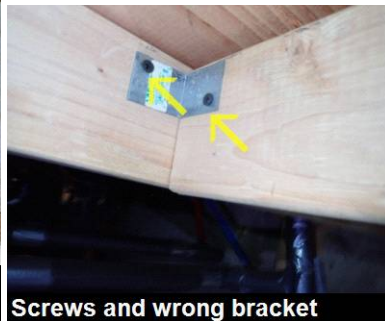
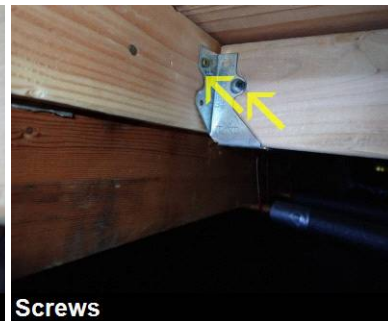
| 13.11 Crawlspace: | <input type="checkbox"/> | <input type="checkbox"/> | <input checked="" type="checkbox"/> | There is at least one post (or knee/pony wall) supporting an overhead beam in the crawlspace. Typically, there are multiple posts supported by concrete piers/footings or pads. They appear to be adequately installed. The post(s) installed are |

| | solid wood. Exposed concrete piers are at least 8" in diameter and are visible in the crawlspace. The piers/footing/pads, as installed, have indications they are adequate. No engineering analysis was completed. Under the kitchen, there are 2x4's installed on the footing. They should have protection of an asphalt roof shingle or they should be pressure treated to prevent wicking of water into the posts. Additionally, incorrect hangers are installed with screws. Proper hangers are needed and galvanized nails should be used to install the hangers. Have a licensed contractor with experience in these conditions evaluate and repair or replace as necessary. |

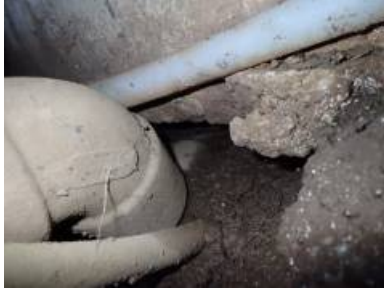
| 13.15 Crawlspace: | <input type="checkbox"/> | <input type="checkbox"/> | <input checked="" type="checkbox"/> | The possible entry point(s) of the crawlspace for vermin is/are: The area where the sewer line exits the crawlspace, should be sealed to prevent vermin entry. Have a licensed contractor with experience in these conditions evaluate and repair or replace as necessary. |

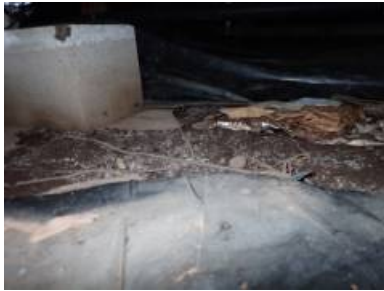
| 13.17 Vapor Barriers In Crawlspace: | <input checked="" type="checkbox"/> | <input checked="" type="checkbox"/> | <input type="checkbox"/> | There is a vapor barrier installed. There is a vapor barrier installed at the floor area of the crawlspace. The floor is covered with an approved vapor/moisture retardant material. There are small section(s) of ground that are exposed. The entire crawlspace should be covered with at least a 6 mil black vinyl covering. Any seams should overlap 12" and the vapor barrier should go up the foundation wall 12". Have a licensed contractor with experience in these conditions evaluate and repair or replace as necessary. |

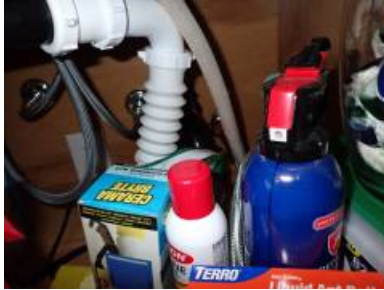
| | OK | MM | RR | |
|---|---|---|---|---|
| 14.1 Kitchen Sink: | <input checked="" type="checkbox"/> | <input checked="" type="checkbox"/> | <input type="checkbox"/> | Minor wear noted. Faucet is serviceable. Drain has a section of corrugated pipe. This will trap debris and should be returned to a smooth wall pipe. Have a licensed contractor with experience in these conditions evaluate and repair or replace as necessary. |

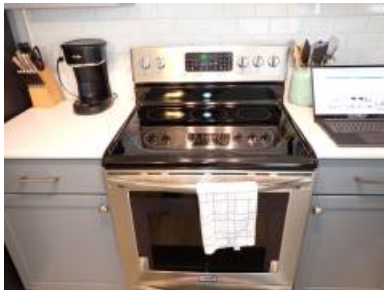
| 14.4 Range/ Cooktop / Oven: | <input type="checkbox"/> | <input type="checkbox"/> | <input checked="" type="checkbox"/> | Electric. Free-standing. Stove has not been secured to prevent the accidental tipping over of the oven. A tip-over hazard exists for small children. Stove should be properly secured to prevent tipping over. Have a licensed contractor with experience in these conditions evaluate and repair as necessary. |

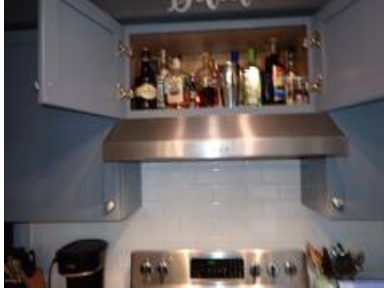
| 14.8 Ventilation: | <input type="checkbox"/> | <input checked="" type="checkbox"/> | <input type="checkbox"/> | The unit does not vent to the outside. This is allowable if there is a open able window or door near by. You should consider routing the hood to the exterior to remove food smells from the home. |

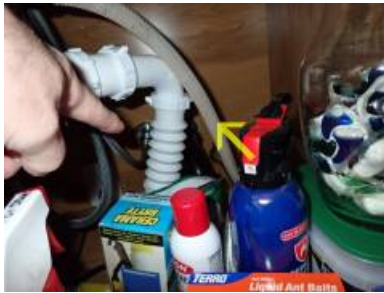
| | OK | MM | RR | |
|---|---|---|---|---|
| 14.9 Dishwasher: | <input checked="" type="checkbox"/> | <input checked="" type="checkbox"/> | <input type="checkbox"/> | Unit is functional. There is no air gap under the sink in the drain line from the dish washer to the garbage disposal or waste drain. Installing one can reduce bad odors. On many newer dishwashers, they install an air gap at the dish washer. This cannot be viewed by the home inspector. You may be able to determine if the manufacture installed it on this unit if you have the instructions or you can install one under the sink. |
